Manhole Inspection Summary

Manhole # S29CC1006MH

Location Address: **500 BEECH AVE**

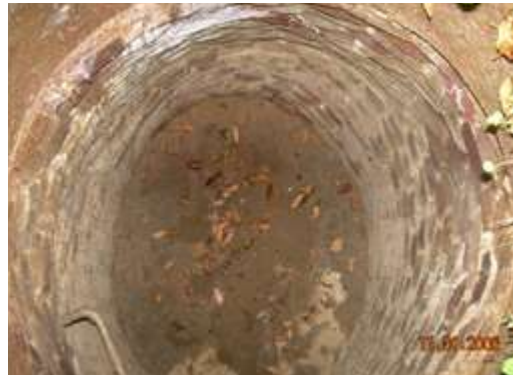
Top View

Channel debris.

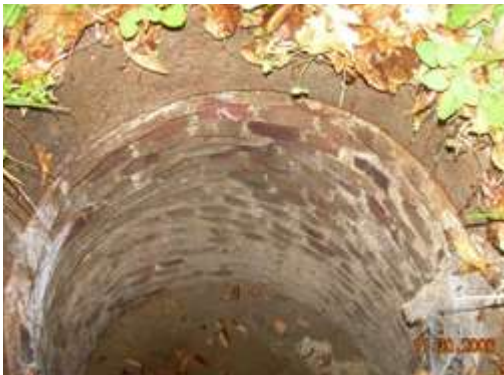
Defect

Infiltration: ☐ None ☒ **Joint** ☐ Cracks ☐ Mortar ☐ Roots ☒ **Wall**

Infiltration: ☐ None ☐ Joint ☐ Cracks ☐ Mortar ☐ Roots ☒ **Wall**

Frame leaks. Corbel and Barrel infiltration.

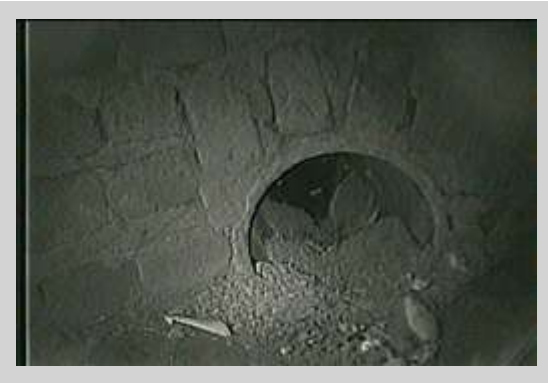
8 in. Circular Gravity Sewer
Pipe Out @ 12 O'Clock

Deposits: ☐ None ☒ **Mud** ☐ Sludge ☒ **Debris** ☐ Grease

Silt Depth: **2** (in.)

Deposits Extent: **Medium**

Infiltration: **Evidence**

Pipe Seal Cond: **Cracked**
